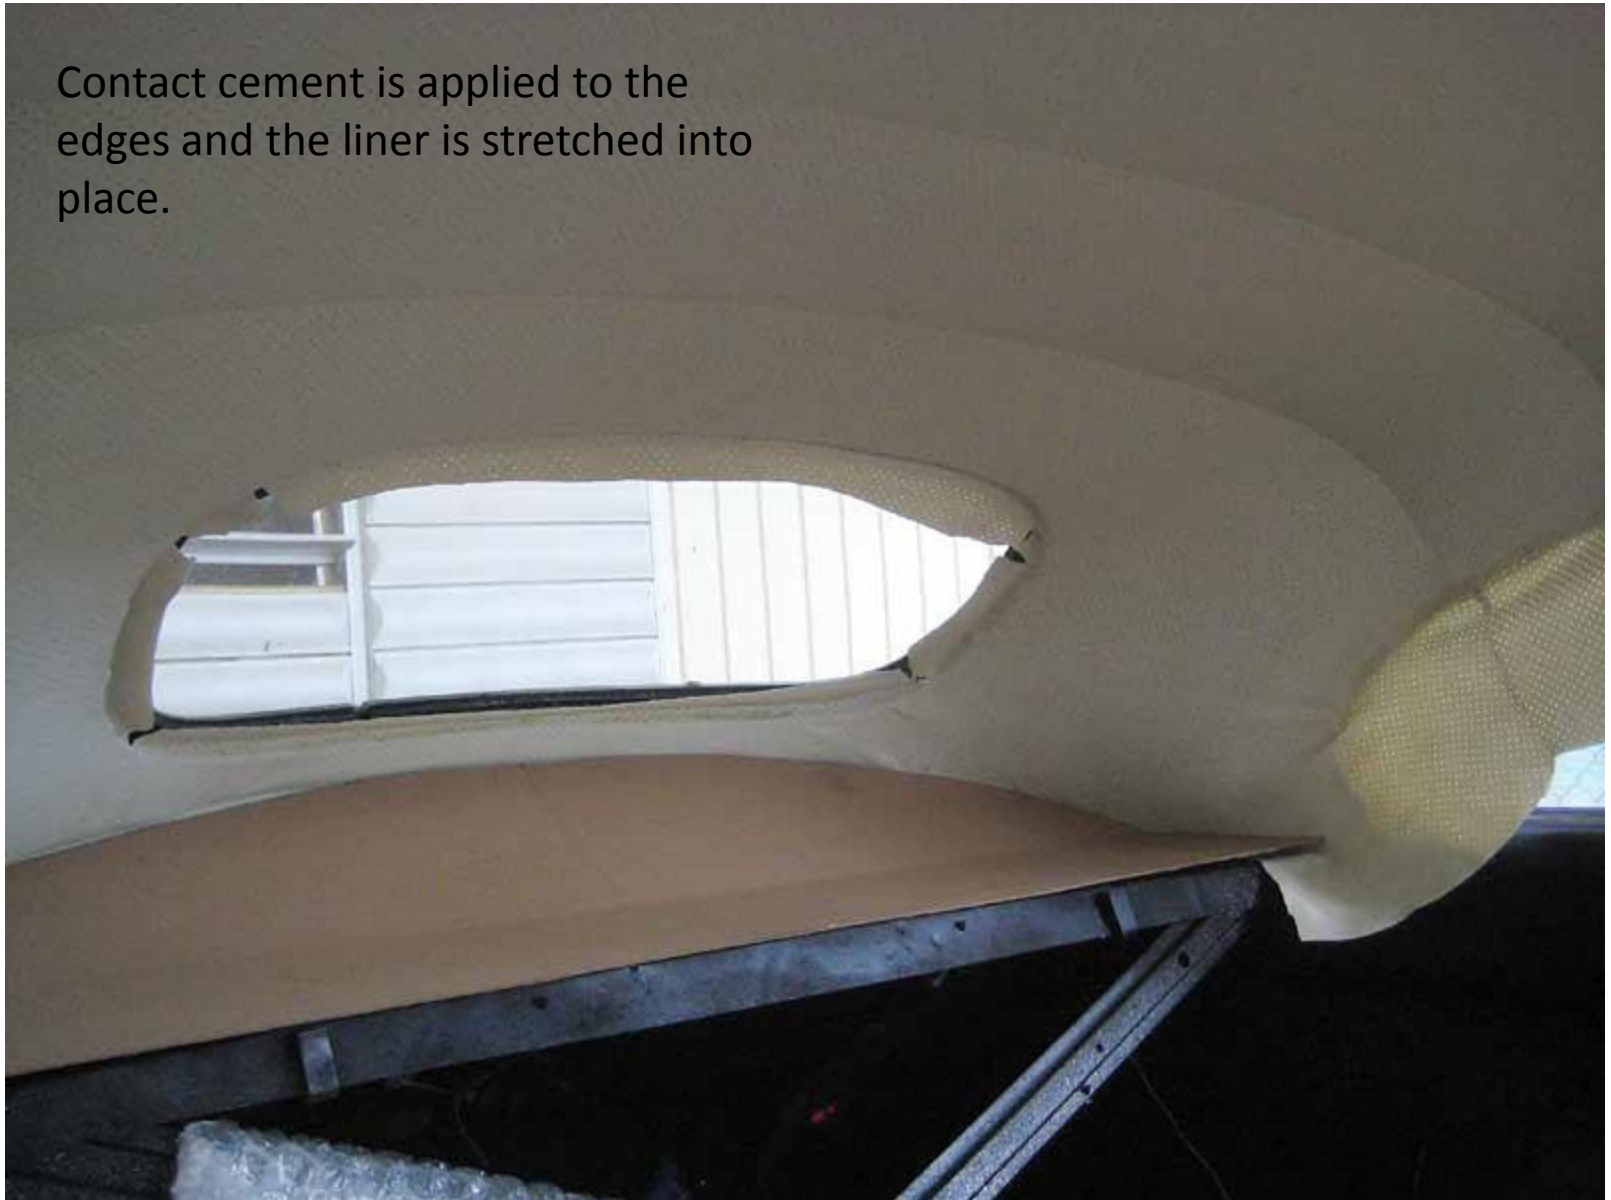
Contact cement is applied to the edges and the liner is stretched into place.

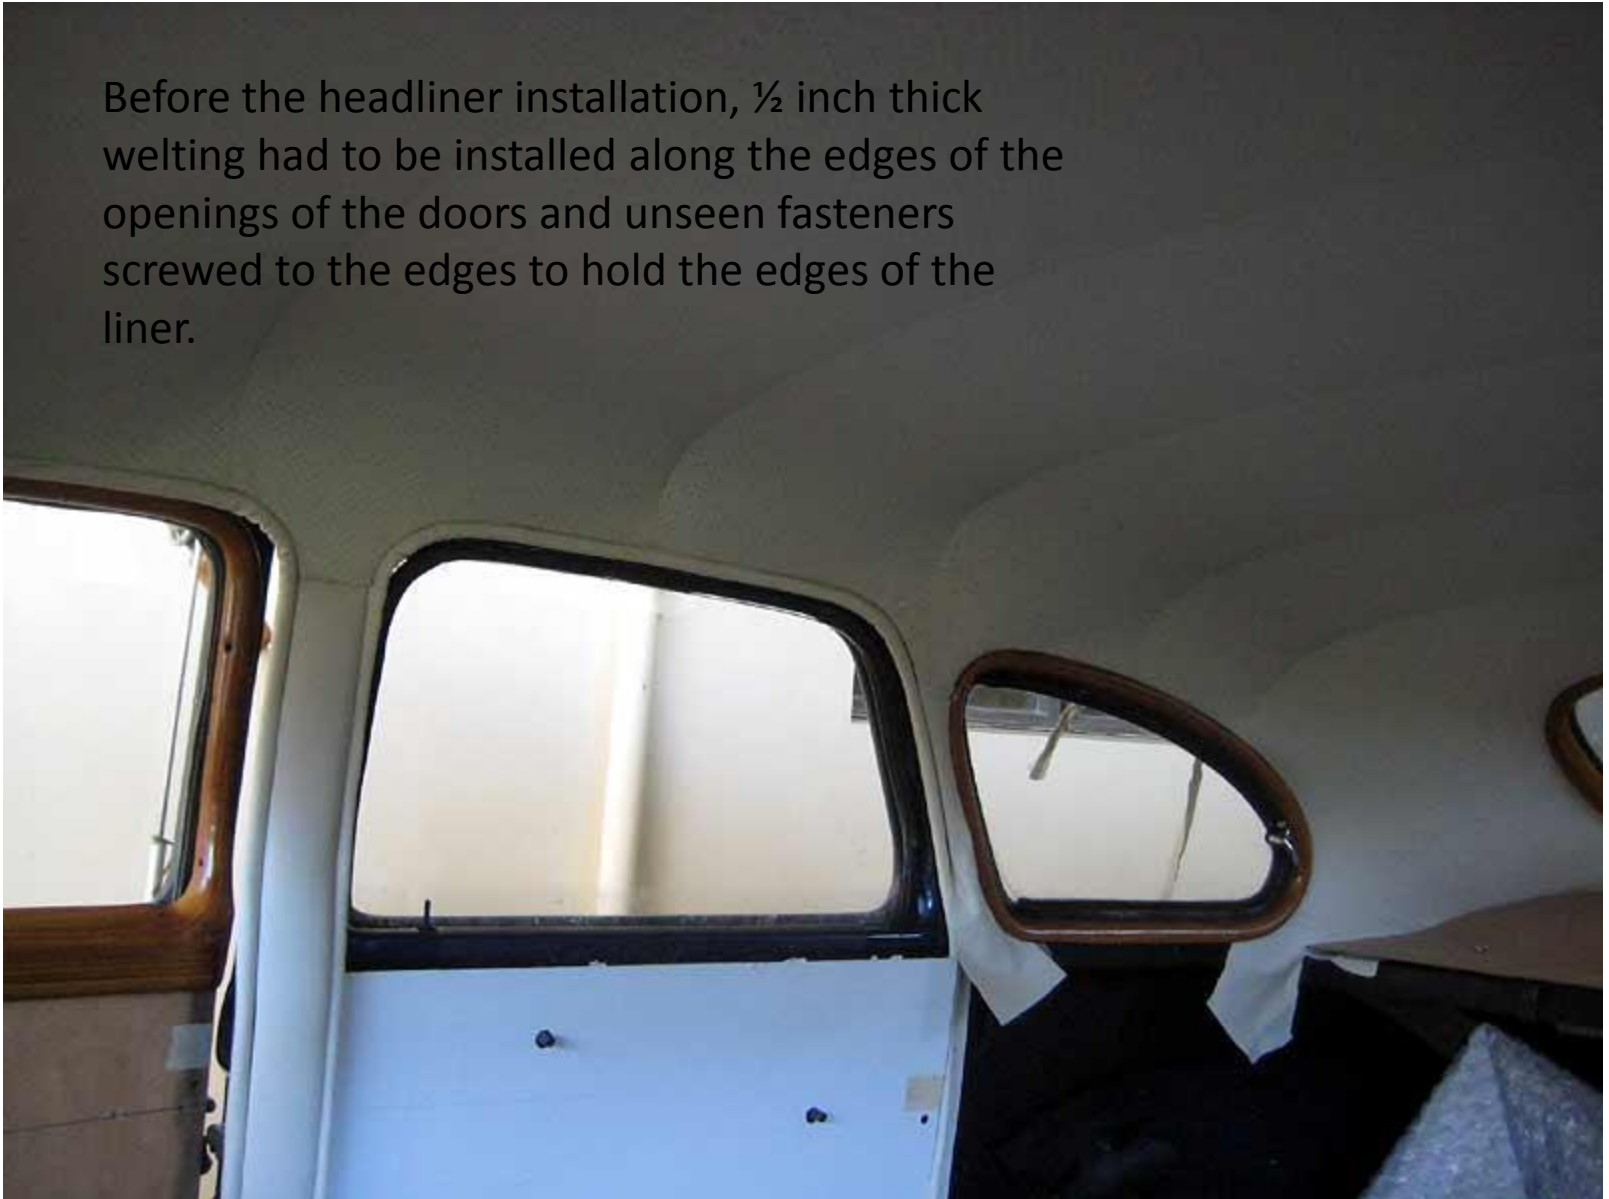
Before the headliner installation, ½ inch thick welting had to be installed along the edges of the openings of the doors and unseen fasteners screwed to the edges to hold the edges of the liner.

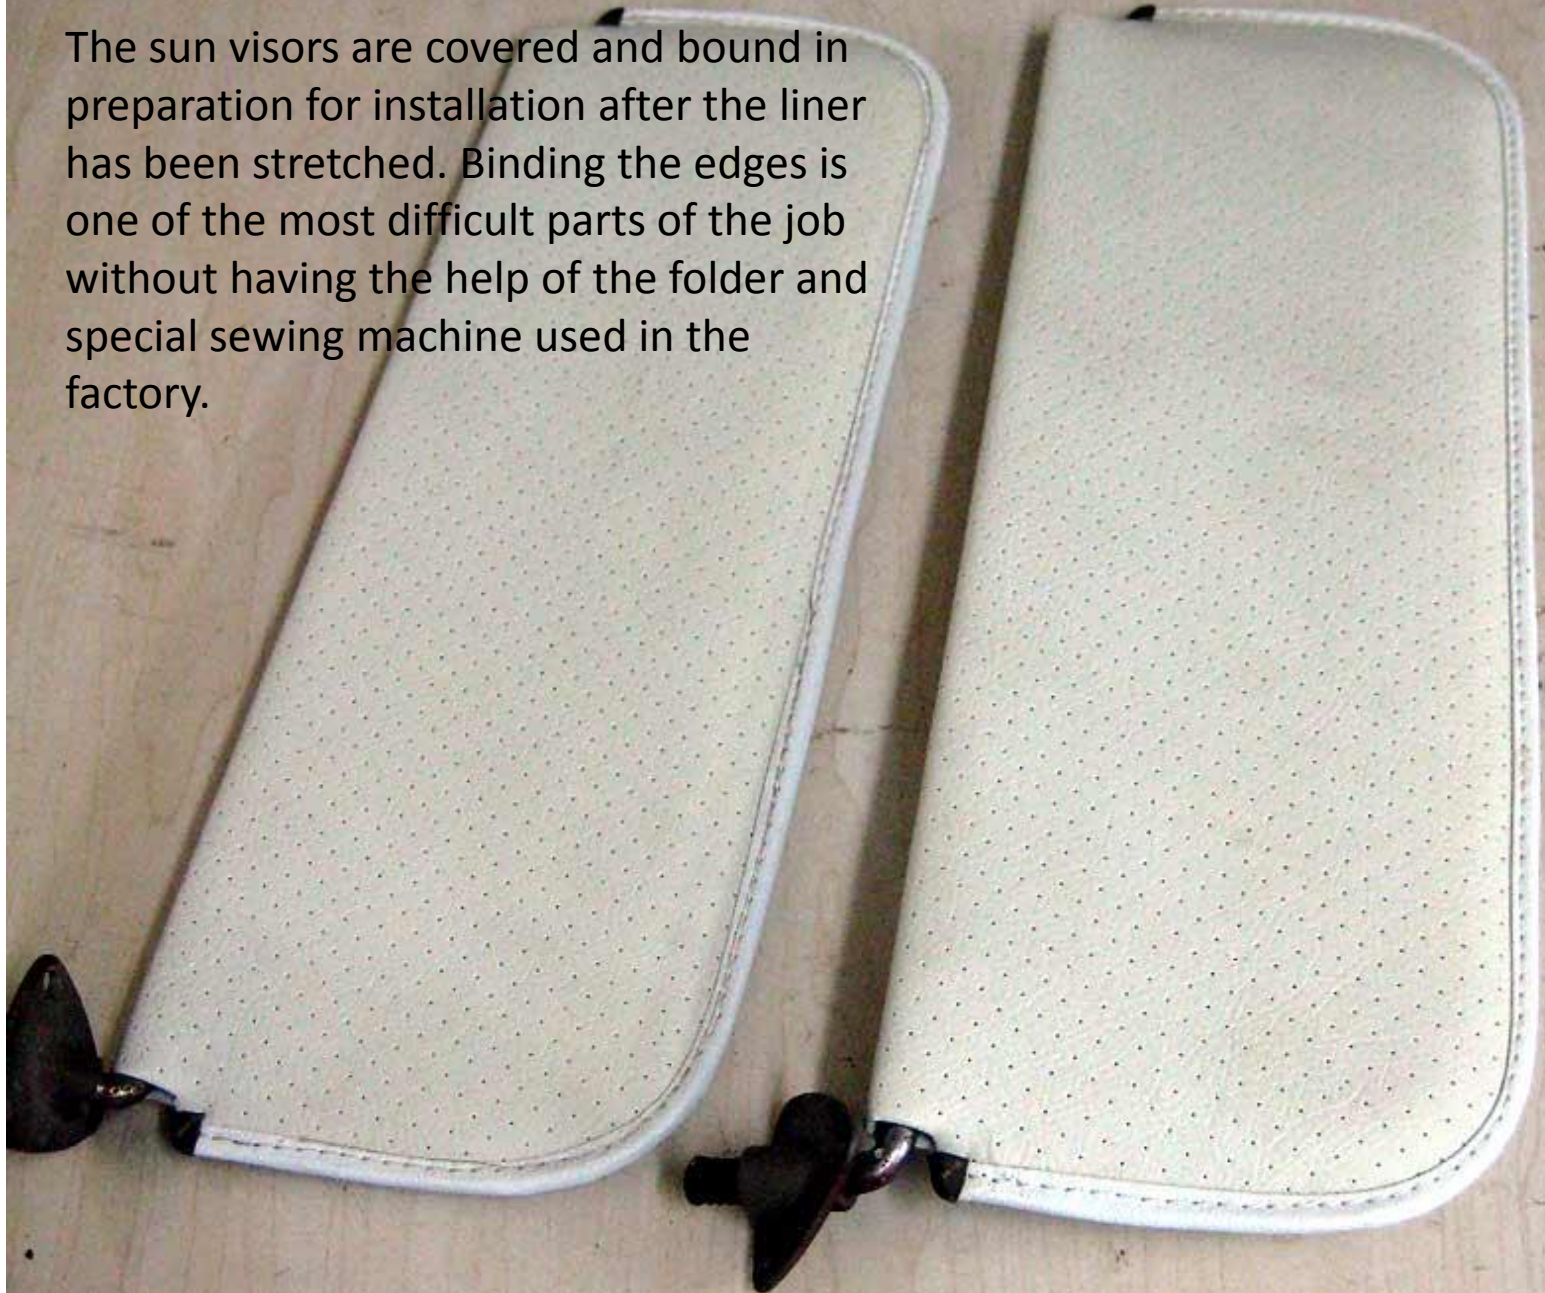
The sun visors are covered and bound in preparation for installation after the liner has been stretched. Binding the edges is one of the most difficult parts of the job without having the help of the folder and special sewing machine used in the factory.

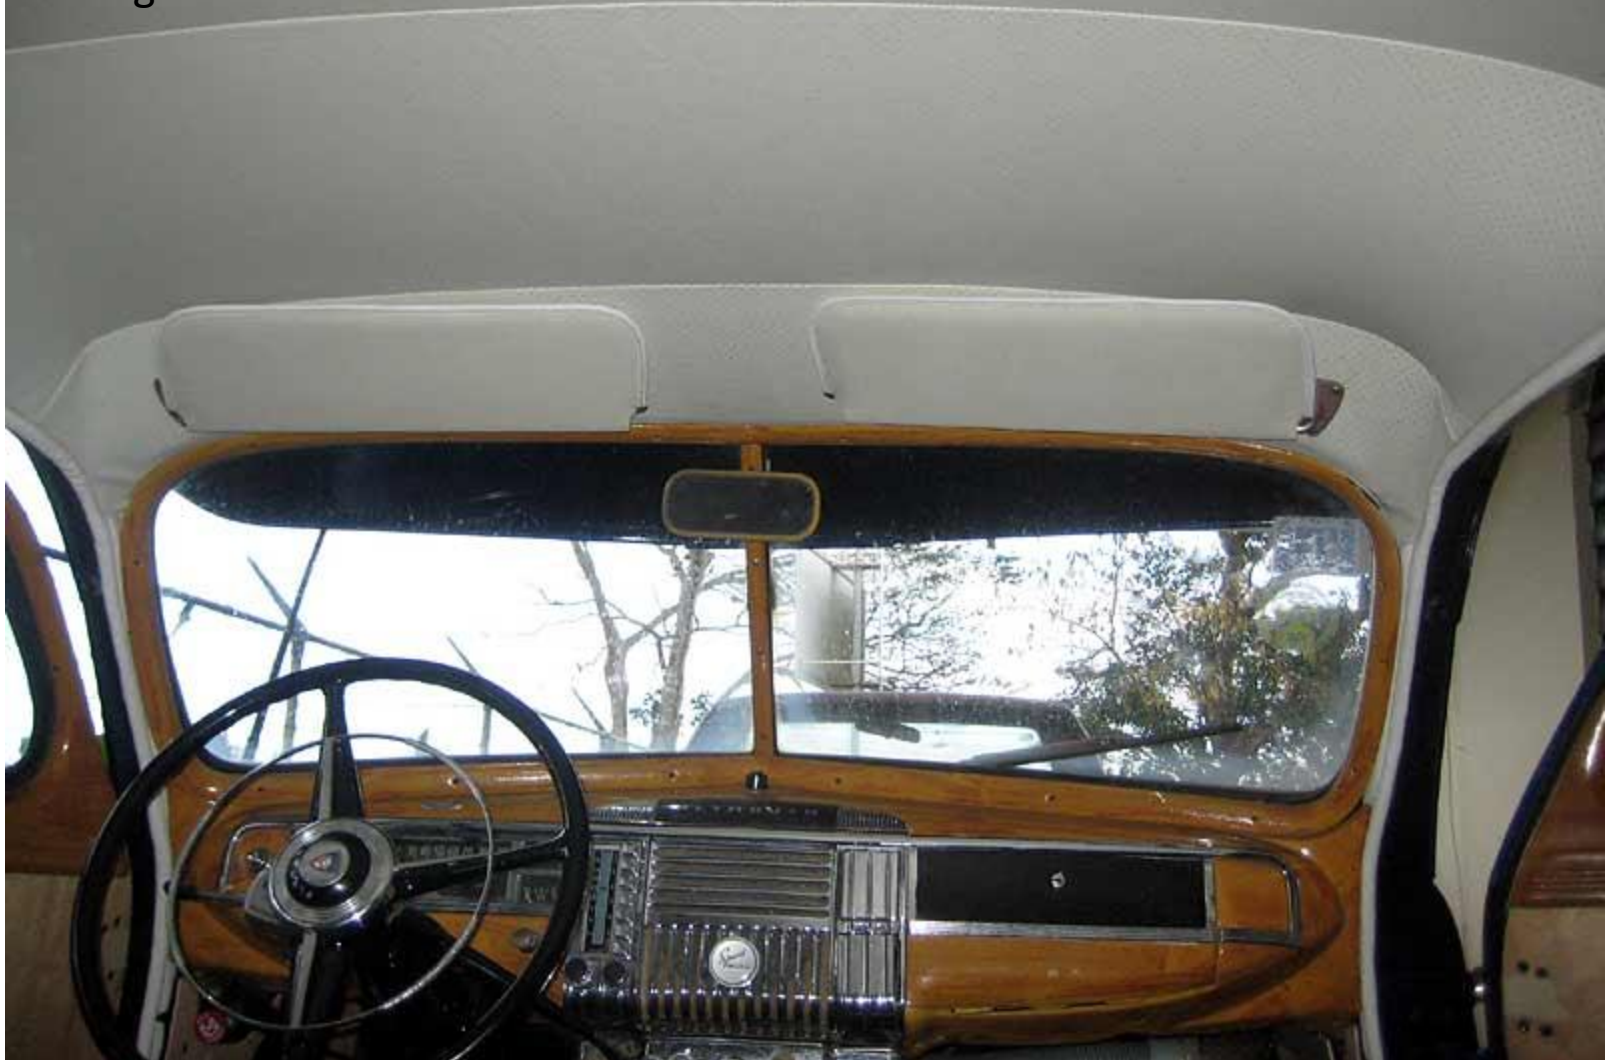
The sun-visors are installed after the window trim goes in .

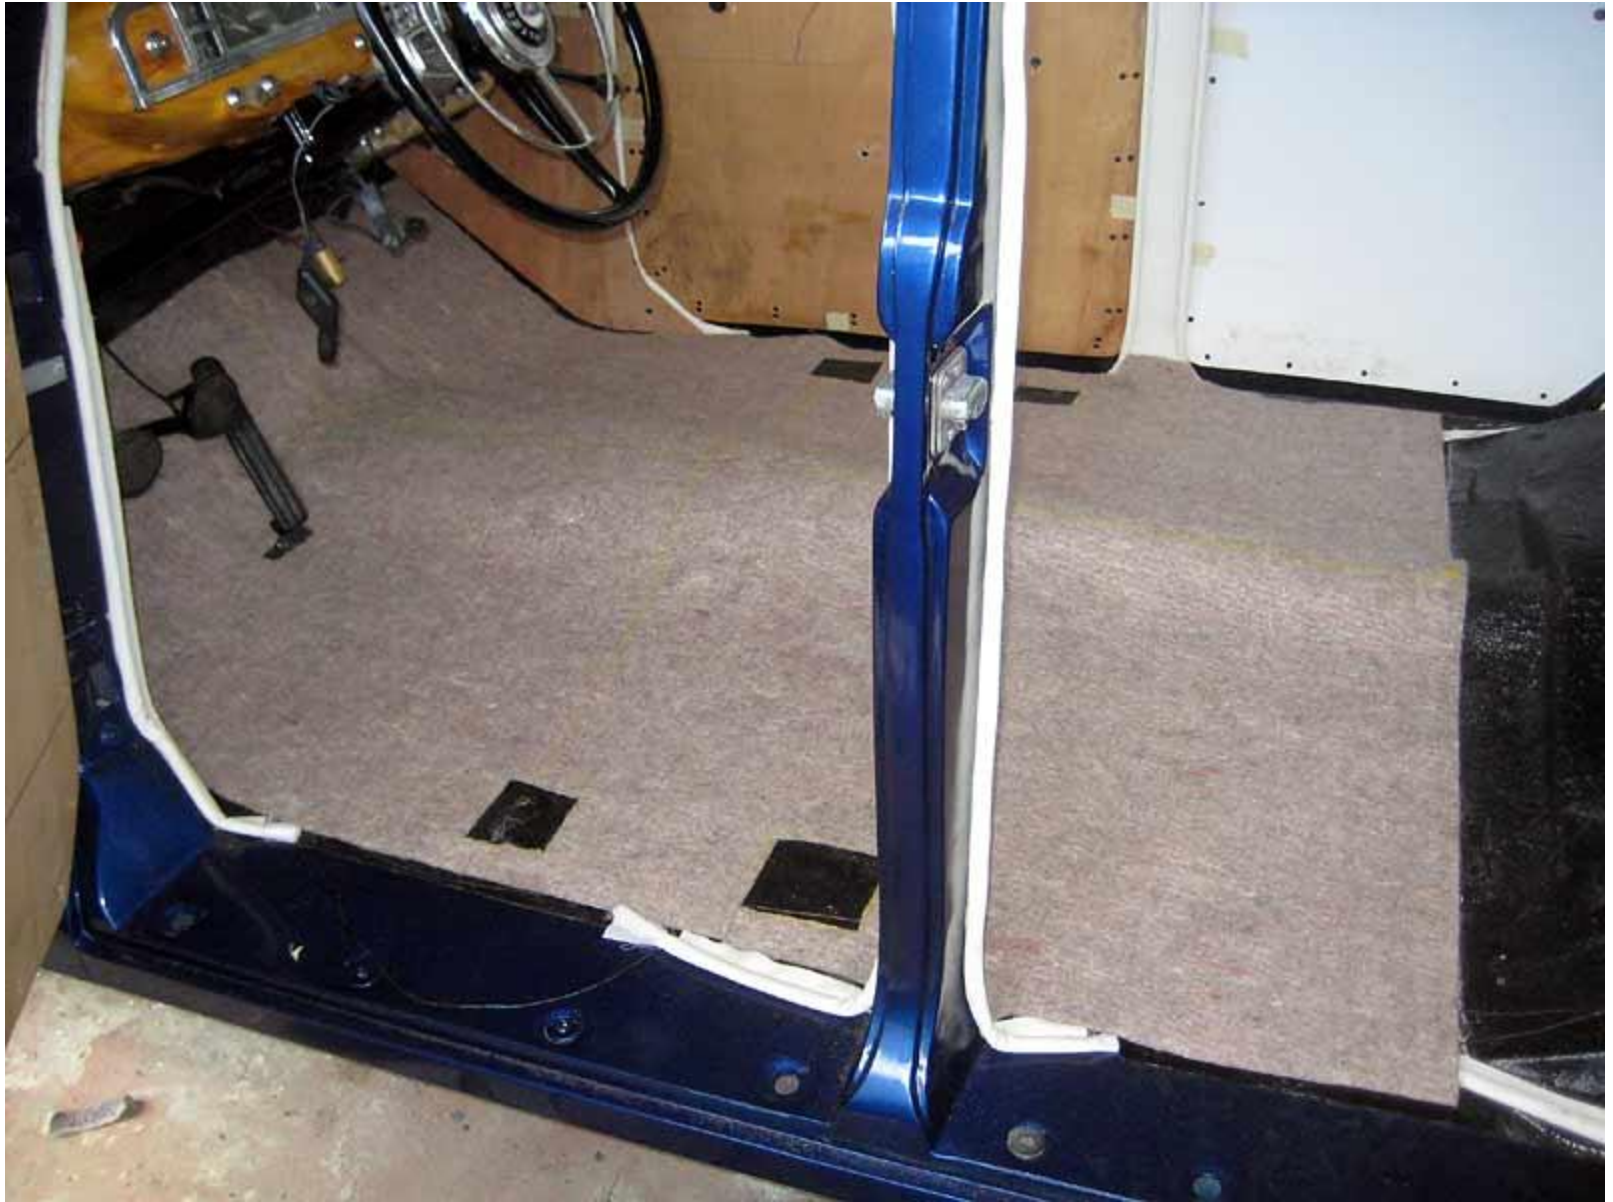
The package shelf is covered in carpet ,
installed, and then the divider is put in
place.
